VARIOUS DOCK LEVELER ISSUES:

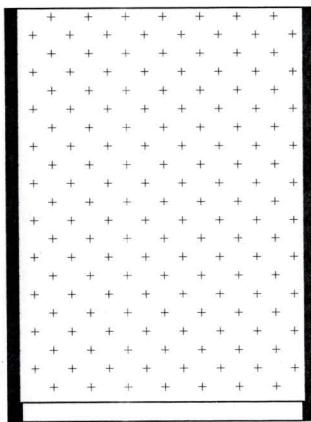
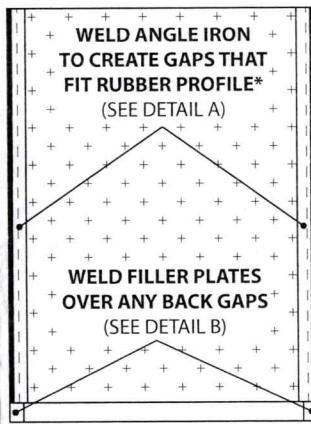
EXTRA-LARGE GAPS - BOTH SIDES

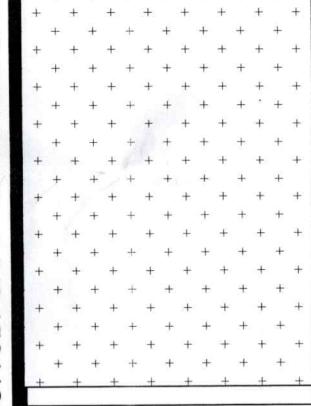
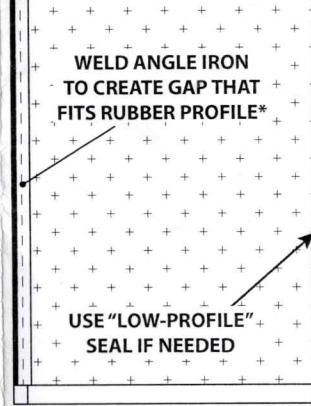
OFFSET GAPS - ONE LARGE GAP

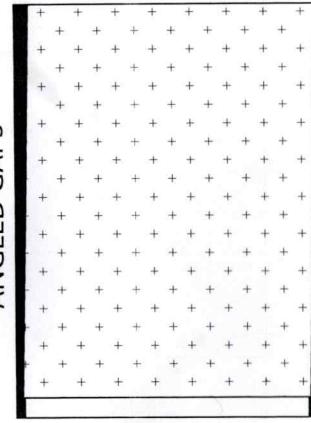
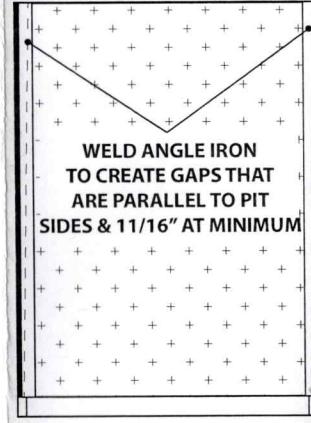
ANGLED GAPS

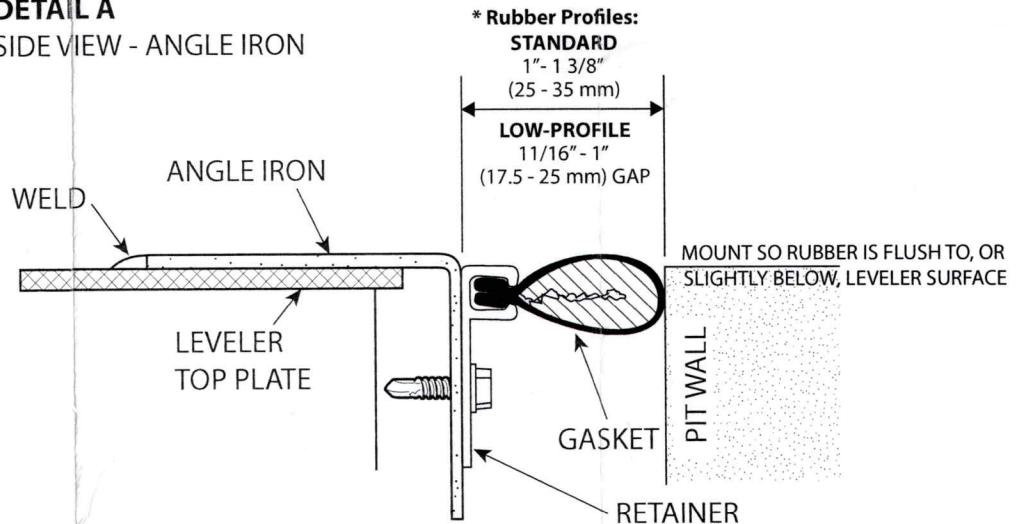
DETAIL A

SIDE VIEW - ANGLE IRON

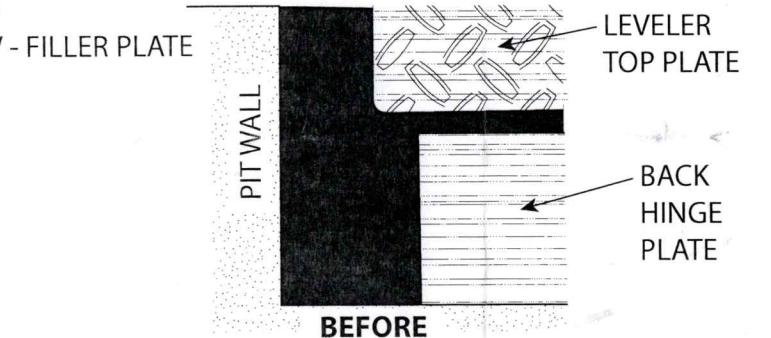
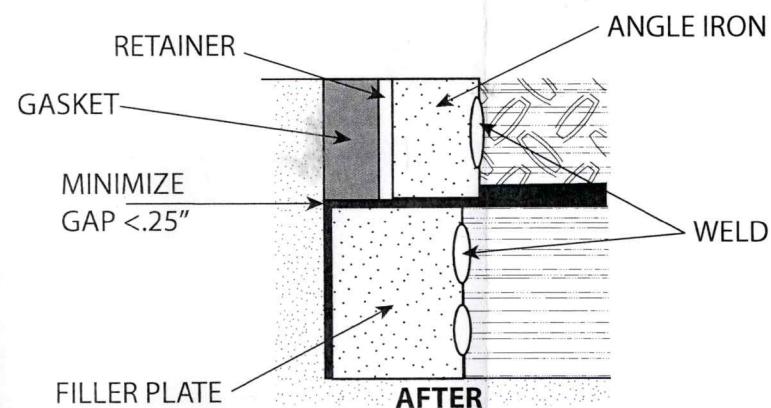
DETAIL B

TOP VIEW - FILLER PLATE
